P. L. 93-251 SECTION 32 DEMONSTRATION
PROJECTS STUDY

MRD HYDRAULIC LABORATORY SERIES
REPORT NO. 8
PRELIMINARY

PRELIMINARY LABORATORY INVESTIGATION
OF SECTION 32 HARD POINT

MEAD HYDRAULIC LABORATORY
MEAD, NEBRASKA

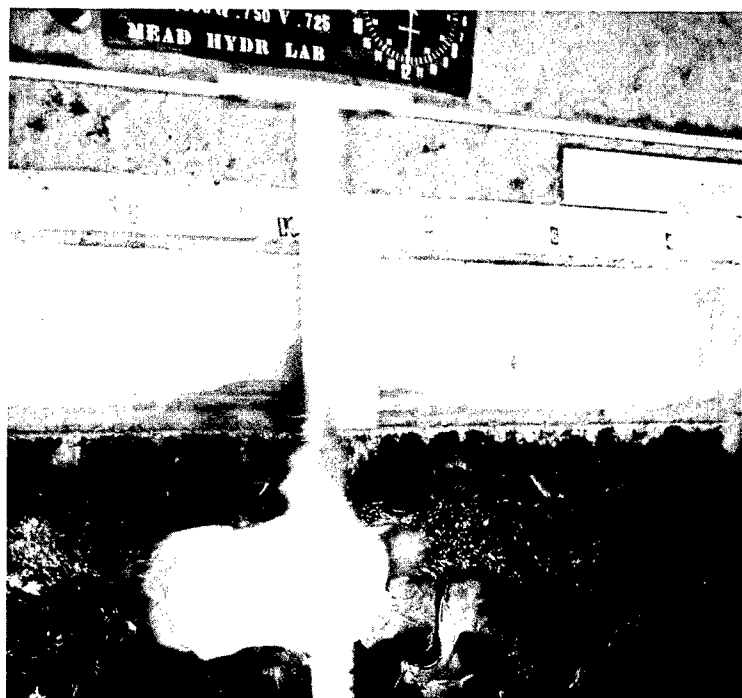
Photograph 1. Leveling test bank by using a male template fixed to a carriage on a rail traverse.

1. The channel bank in the test area was completely rebuilt before each test. It was shaped to the desired configuration by pulling a male template back and forth across the bank material. See photo 1. The template was mounted on a carriage which rolled along a system of uniform elevation railing. This resulted in a berm with a top elevation of 1.500 feet, a top width of 1.6 foot, a length of 20 feet, and a bank slope of 1 vertical to 2 horizontal.

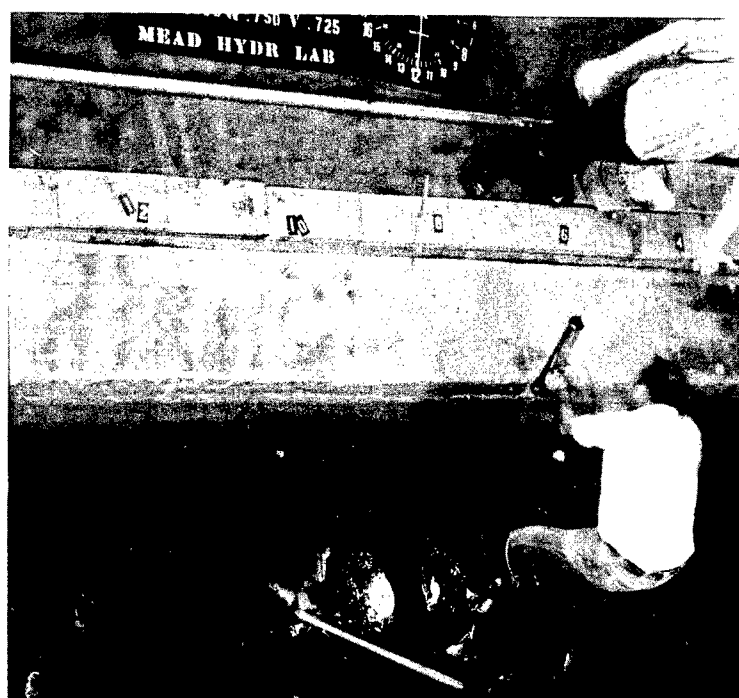
Photograph 2. Excavation of the root trench into the right bank.

2. A trench for the hard point root was then cut in the bank and the rock structure was built by placing the crushed limestone riprap into the trench. See photo 2.

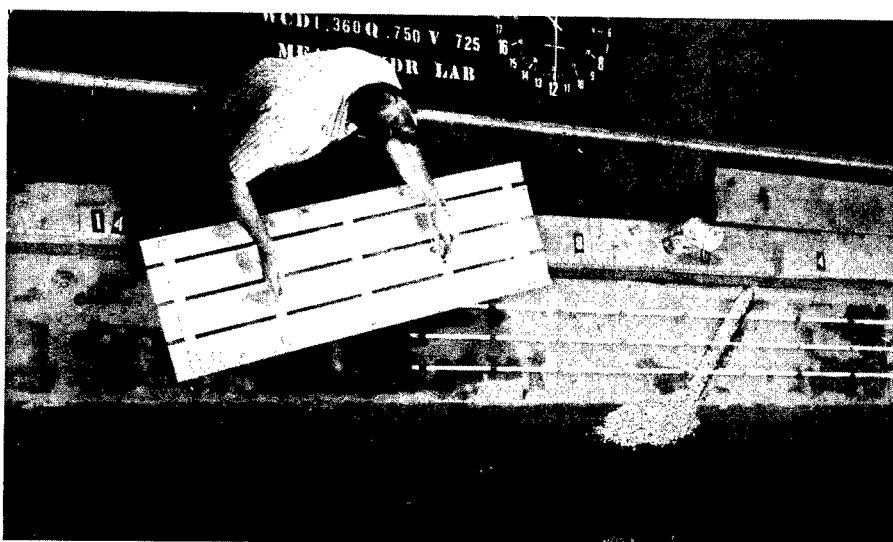
Photograph 3. Marking procedure for the horizontal reference lines on the test bank. Note hard point structure in place.

3. The berm was then gridded with .05 ft. wide lines using a white powder. The grid lines were spaced 1.0 ft. by 0.4 ft. with the larger spacing parallel to the channel. This grid system served as a reference to measure bank erosion while the model was in operation. See photo 3.

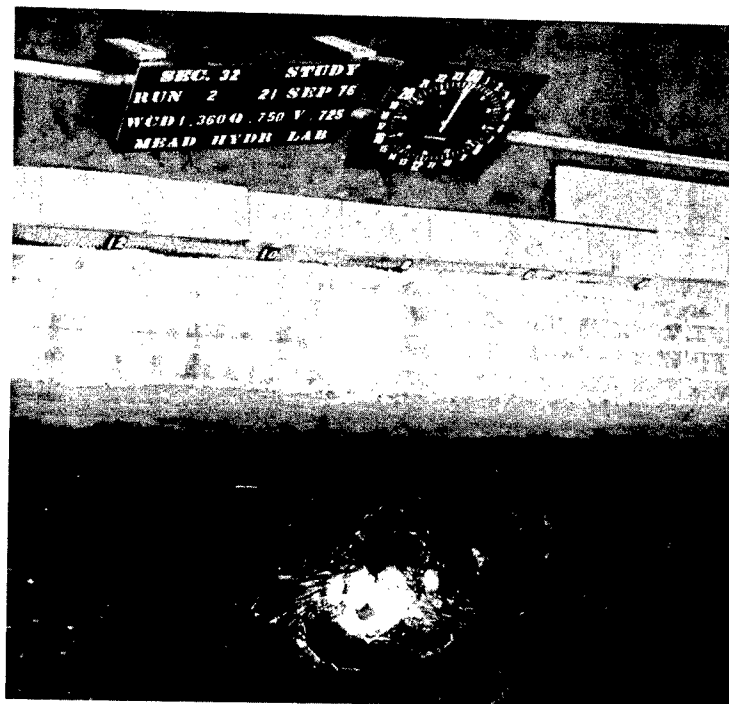
Photograph 4. Test bank arrangement prior to run 2. Notice that this run had no hard point structure.

Test run 2 had no hard point structures positioned in the right channel bank. This run was used to determine the amount of bank area which would be removed by erosion without any type of protection. At the upstream end of this run (station 1.7), the flow expanded off the end of the fixed rock re-vetted slope and caused the right bank erosion to extend to station 6.5. See photos 4 and 5 and plate 2. Station 6.0 was, therefore, selected as the location for the various hard point structures in the forthcoming model tests.

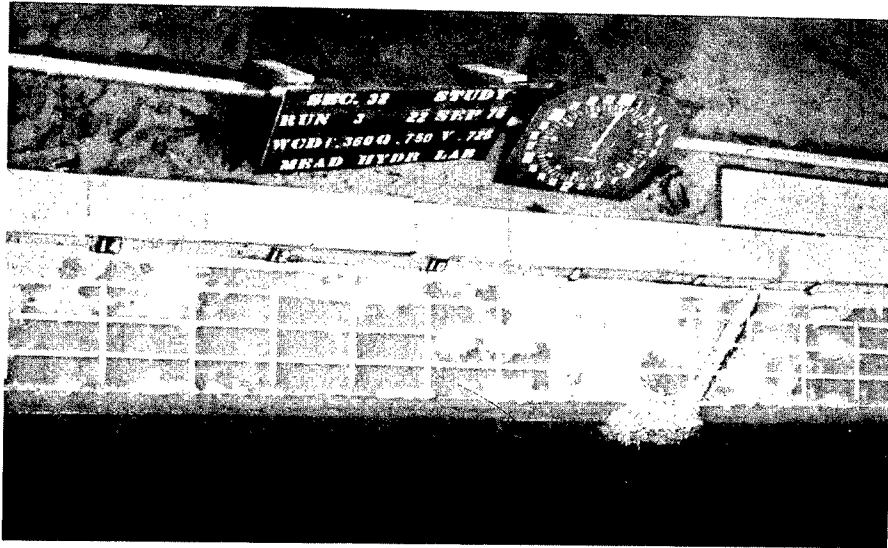
Photograph 6. Test bank arrangement prior to run 3.

The layouts of the different hard point structures are shown on plate 2 and in photographs 6 through 17. For test runs 3, 7, and 8, the hard point structures were constructed out to the edge of the channel bank. For test runs 4, 5, and 6, the hard point structures were extended 0.5 foot further into the channel. This was done in an attempt to determine if this would decrease the amount of bank erosion which occurred downstream from the hard point structures.

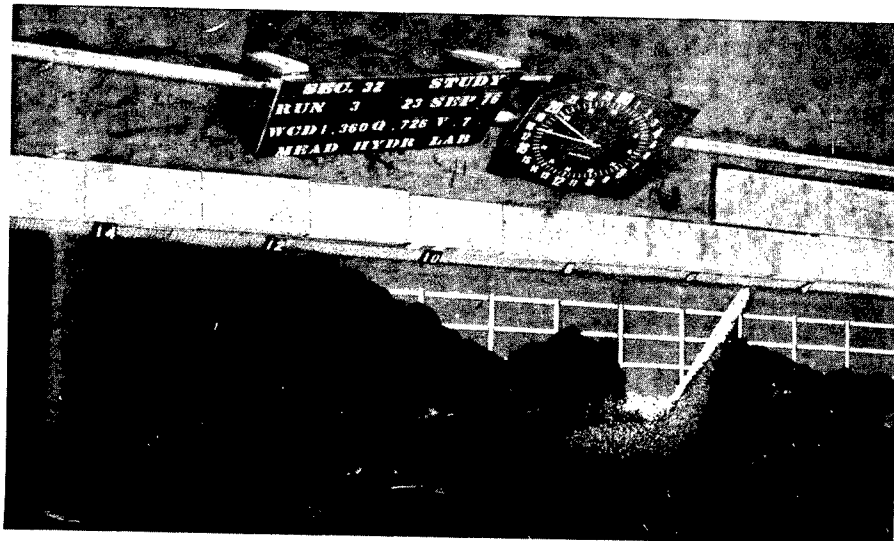
Photograph 7. Resulting channel bed and bank configurations at the end of run 3.

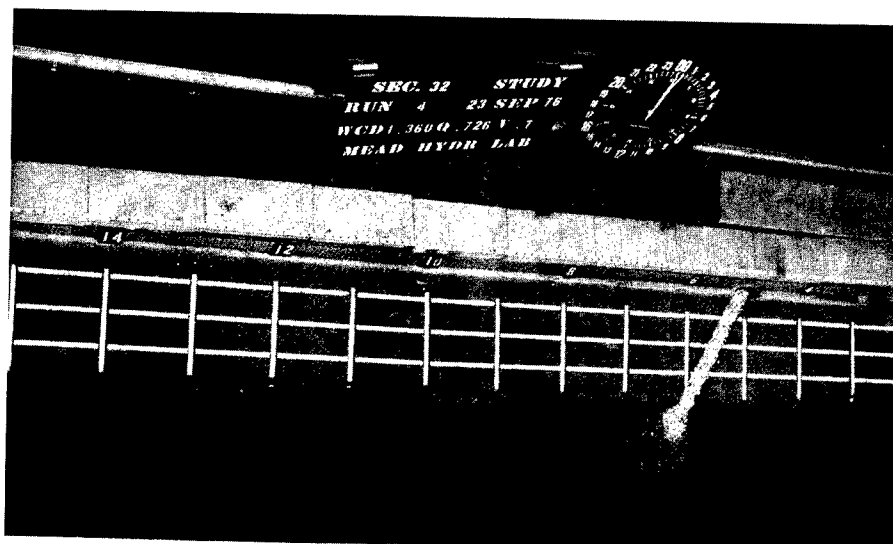
Photograph 8. Test bank arrangement prior to run 4.

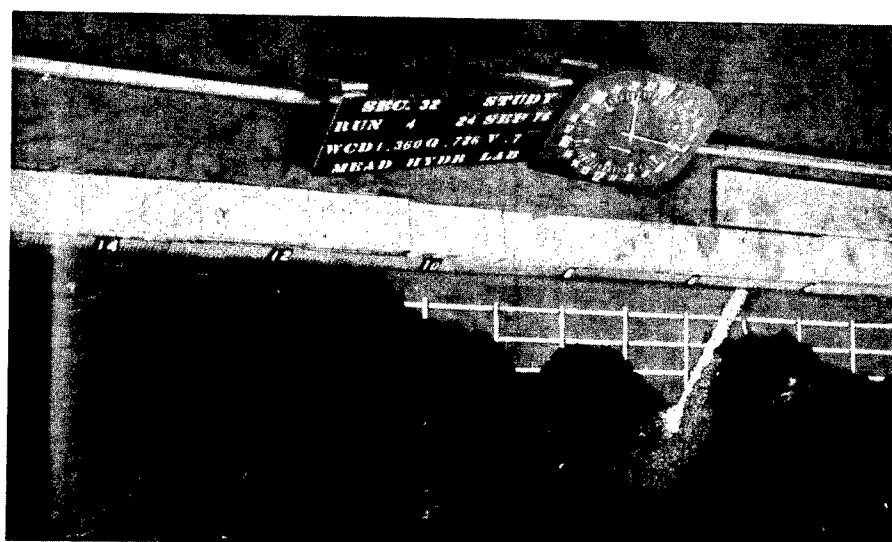
Photograph 9. Resulting channel bed and bank configurations at the end of run 4.

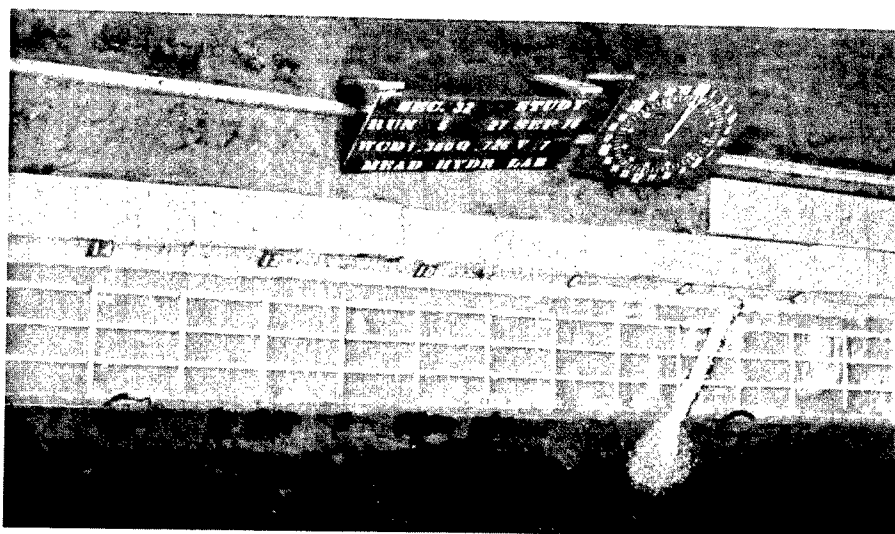
Photograph 10. Test bank arrangement prior to run 5.

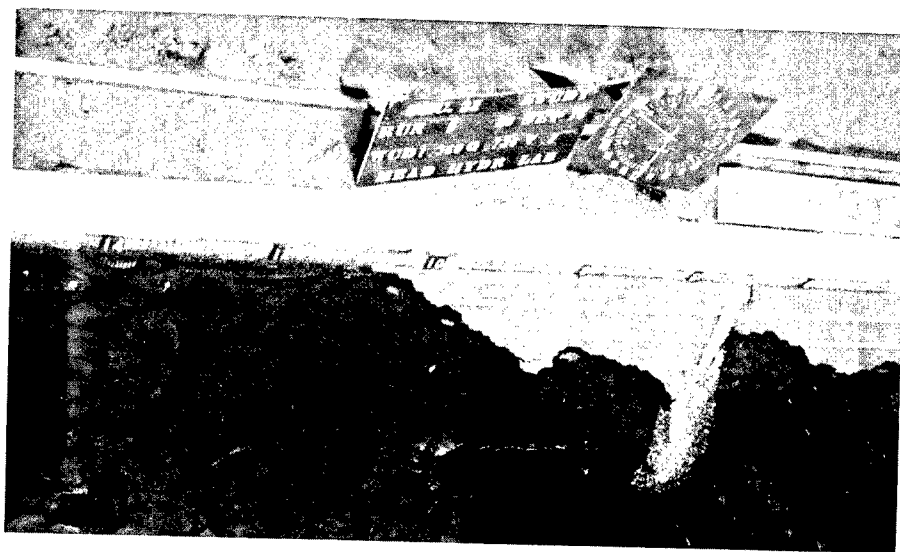
Photograph 11. Resulting channel bed and bank configurations at the end of run 5.

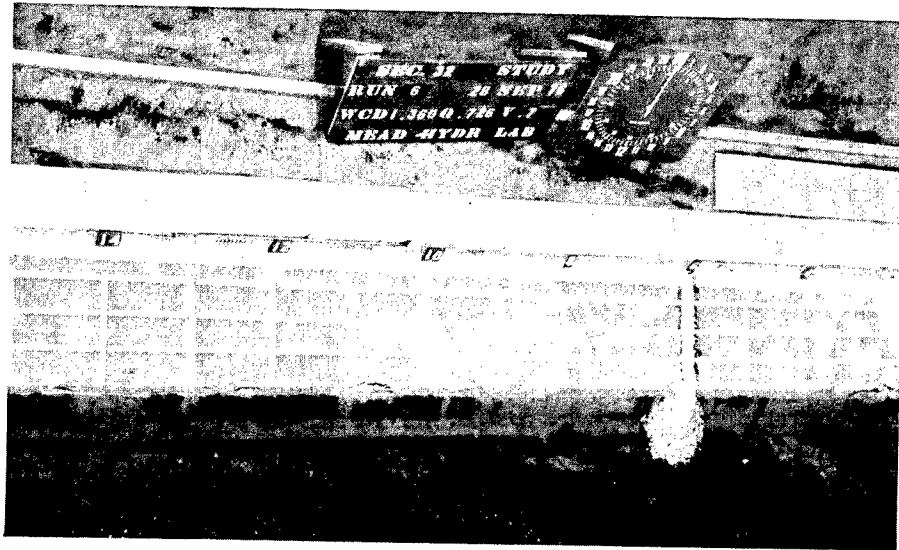
Photograph 12. Test bank arrangement prior to run 6.

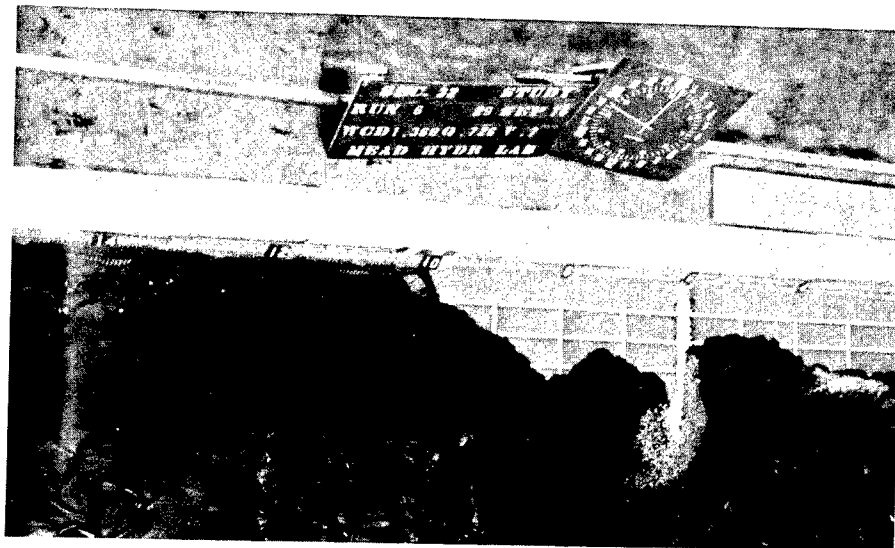
Photograph 13. Resulting channel bed and bank configurations at the end of run 6.

The effect of the 0.5 foot riverward extension of a perpendicular root structure can be seen in the comparison of run 6 with run 7. The extension of the structure in run 6 protects more bank area downstream but uses a greater quantity of rock to armor the upstream slope of the hard point structure. The channel constriction caused by the hard point extension increases the channel velocities and, thus, results in a larger and deeper scour hole.

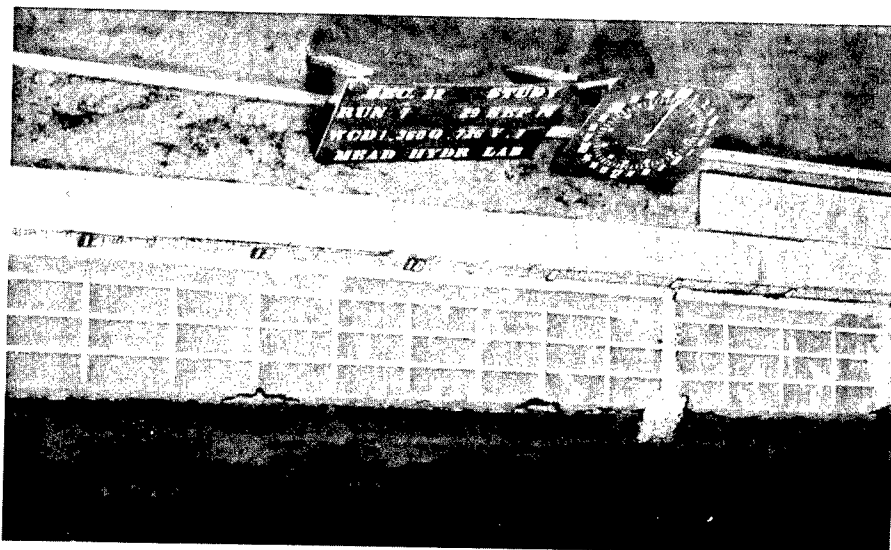
Photograph 14. Test bank arrangement prior to run 7.

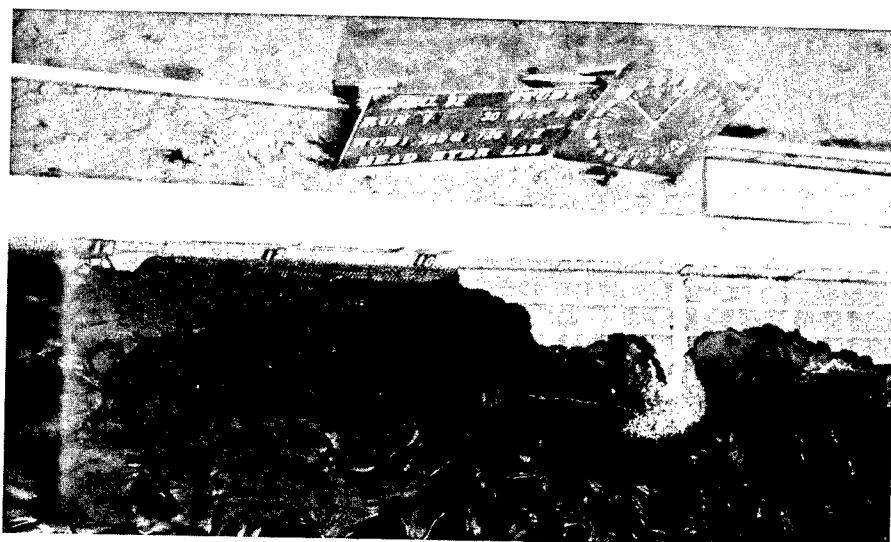
Photograph 15. Resulting channel bed and bank configurations at the end of run 7.

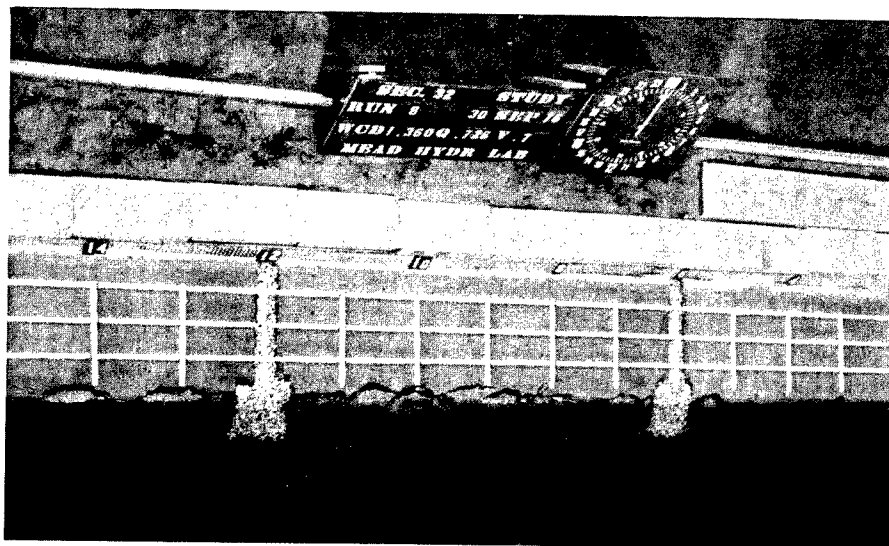
Photograph 16. Test bank arrangement prior to run 8.

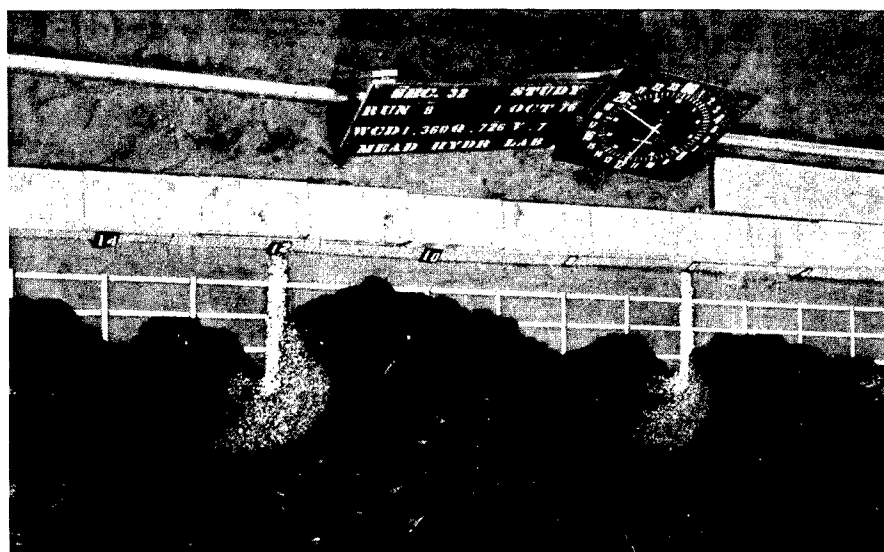
Photograph 17. Resulting channel bed and bank configurations at the end of run 8.

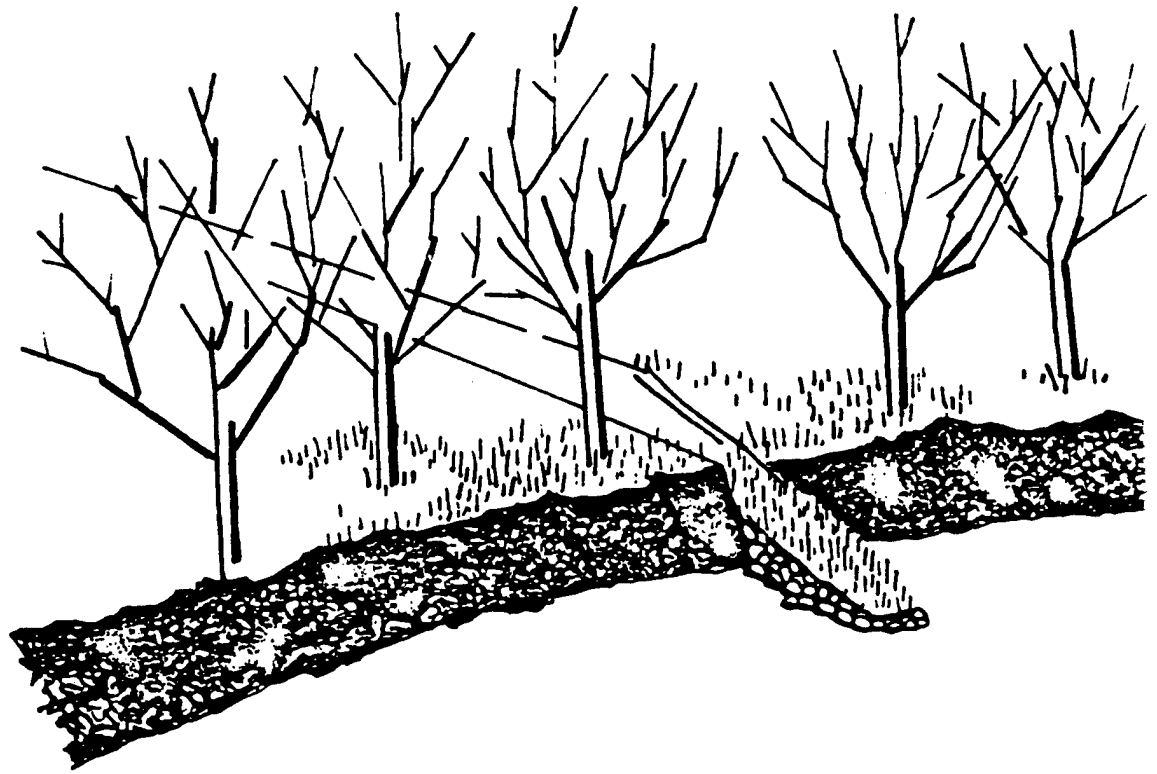
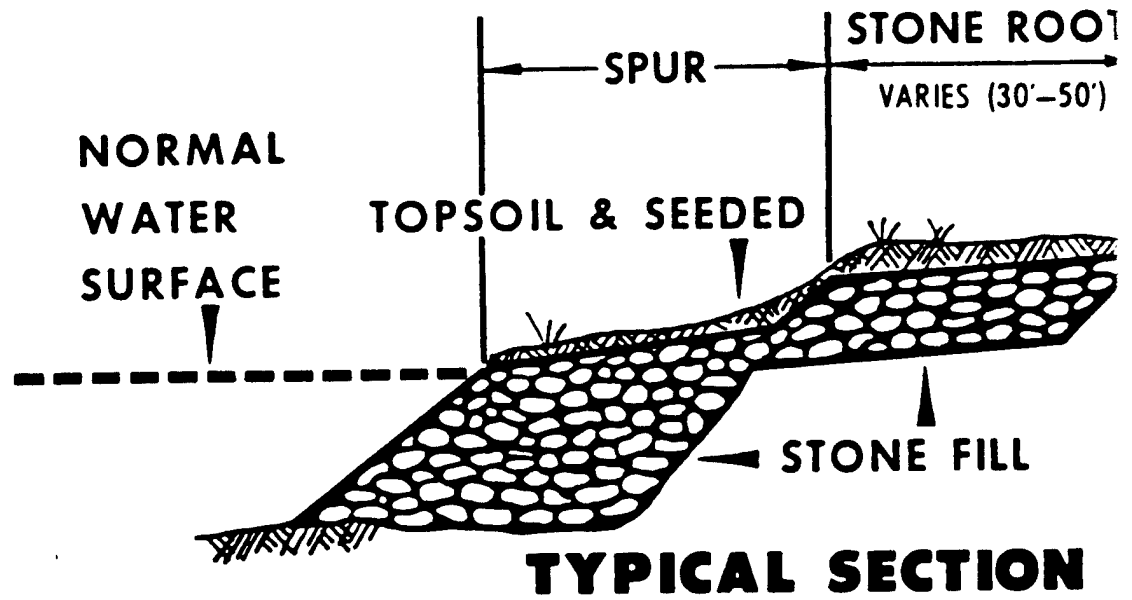
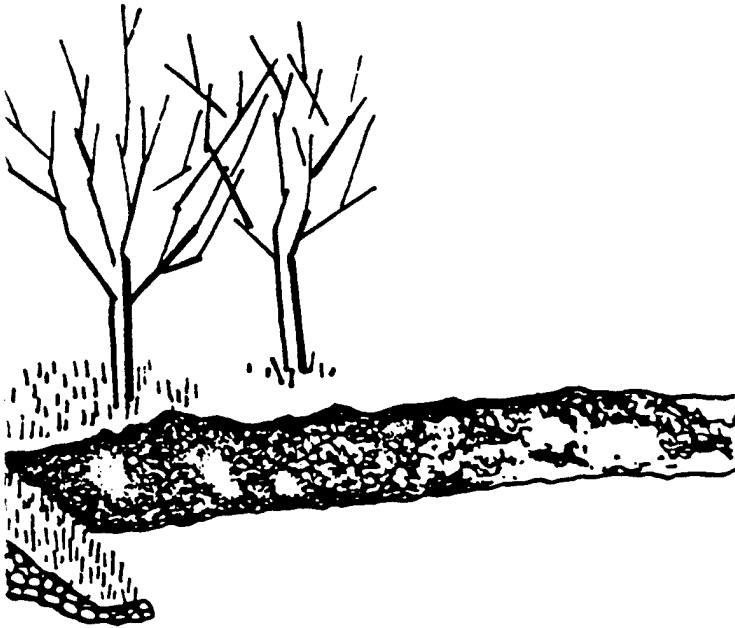
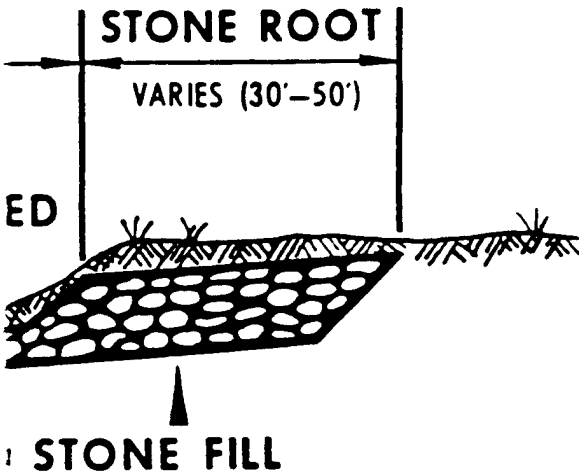
PLATE 1

SECTION 32 DESIGN STUDY
EROSION CONTROL USING HARD POINTS
TYPICAL SECTION

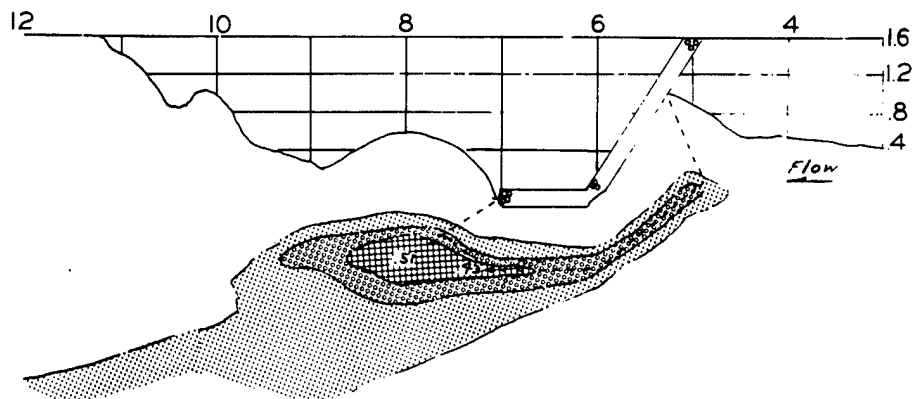
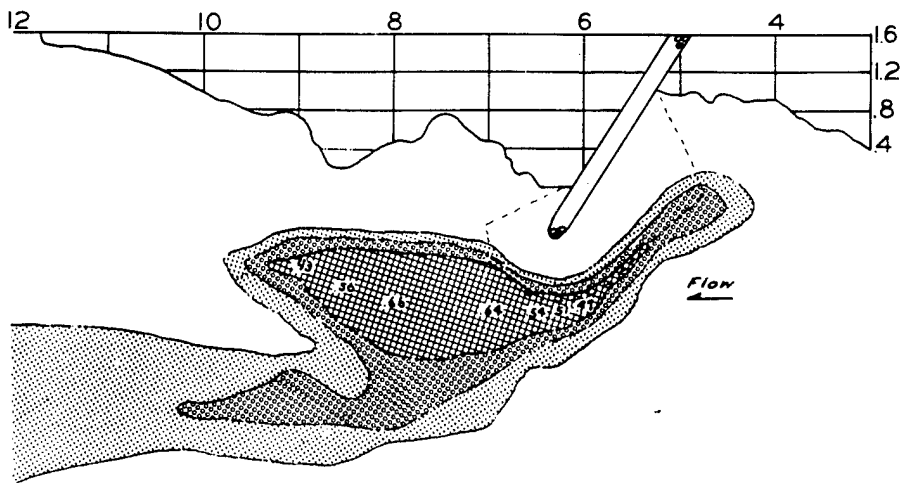
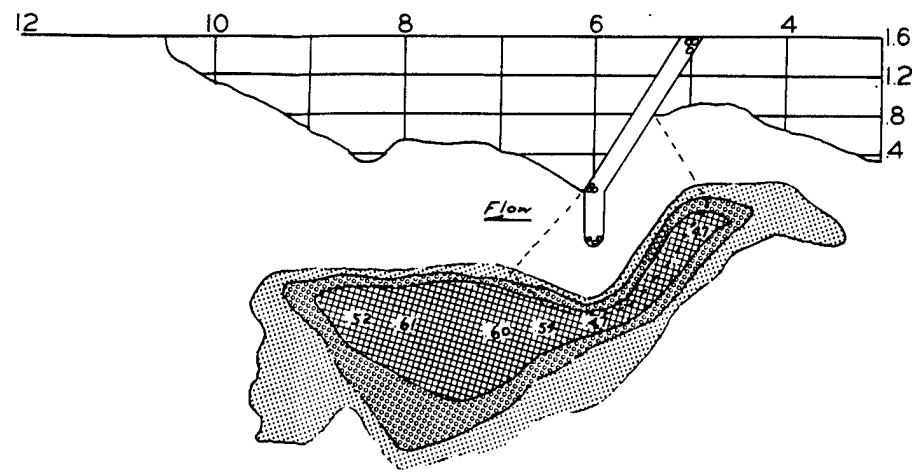
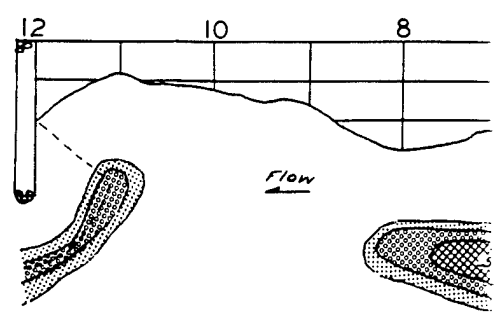
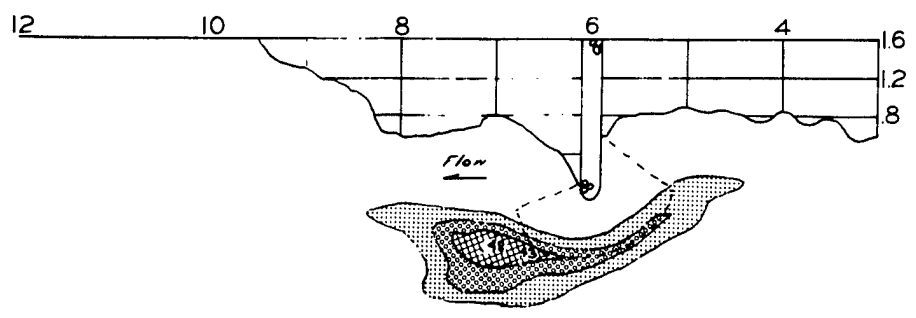
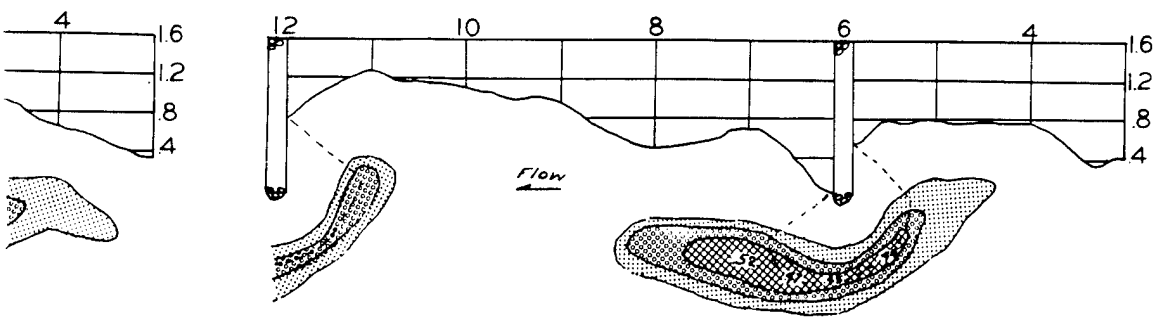
RESULTS OF TEST RUNS
U.S. ARMY ENGINEER DISTRICT, OMAHA
CORPS OF ENGINEERS OMAHA, NEBRASKA

Runs 3 through 8 (plate 2) indicate the amount of bank erosion, which occurred in run 2, was considerably reduced by a hard point structure located at station 6. Runs 4, 5, and 6 had more bank area saved than the other runs.

These runs had structures which extend 0.5 feet further riverward than the other runs. Of these three runs, the structures with angled roots had more bank area protected than the structure whose root was perpendicular to the channel bank. However, the angled root structures had more rock accumulated on the underwater slope than did the perpendicular root structure. See plate 2.

The slow-motion portion of the time-lapse movie indicated that the eddy areas were larger when the structures were placed 0.5 feet further riverward from the channel bank. These structures also had larger and deeper scour holes associated with them. See plate 2. The larger scour holes were created by the increased channel velocities caused by the constriction of the channel from the longer hard point structures. These longer structures had more area of hard point structure exposed to the flow in the channel and, consequently, used a larger amount of riprap to protect the underwater slope. See plate 2. Plots of scour hole lengths, widths, and depths downstream from the ends of the hard point structures are shown on plate 3. The bank erosion line and scour hole angles are also shown on plate 3.

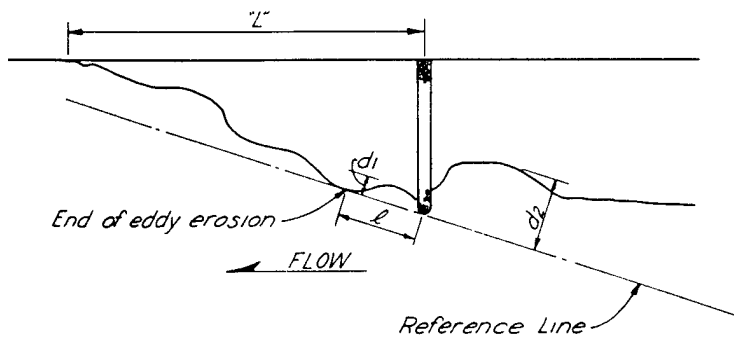
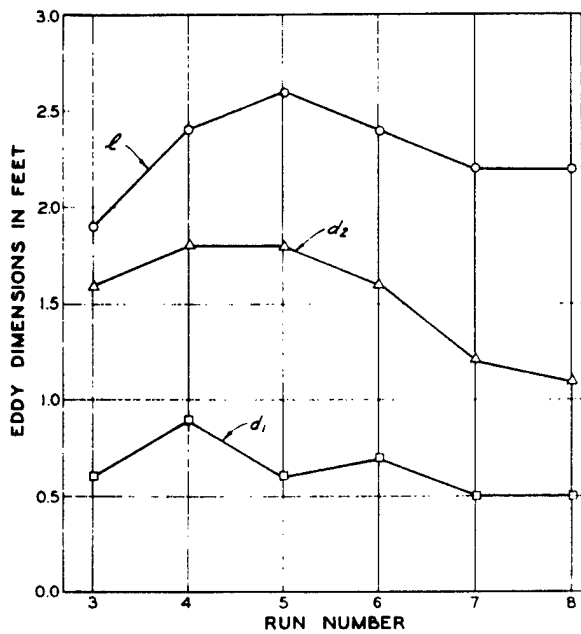
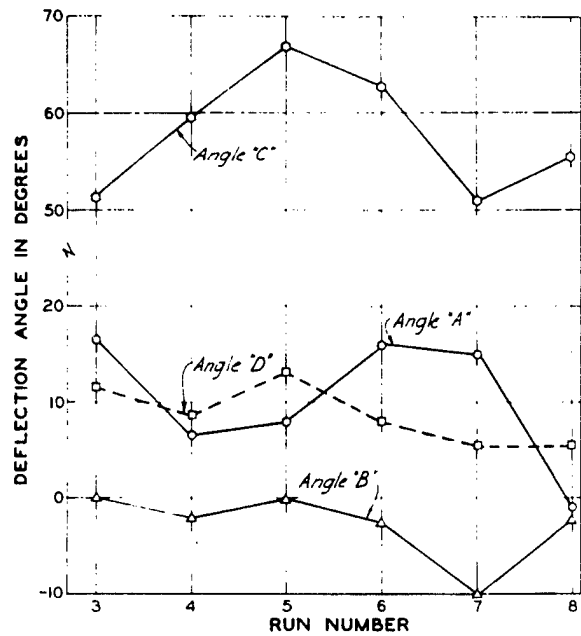
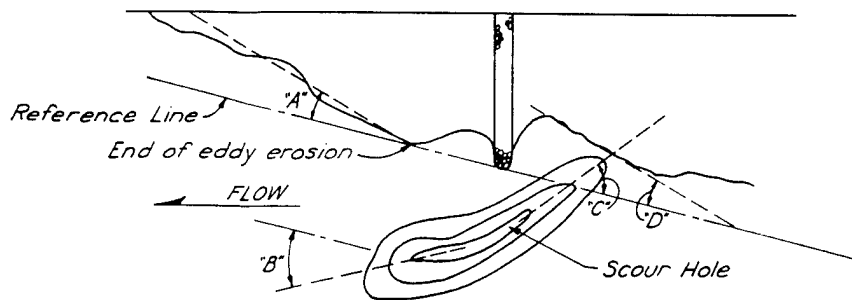
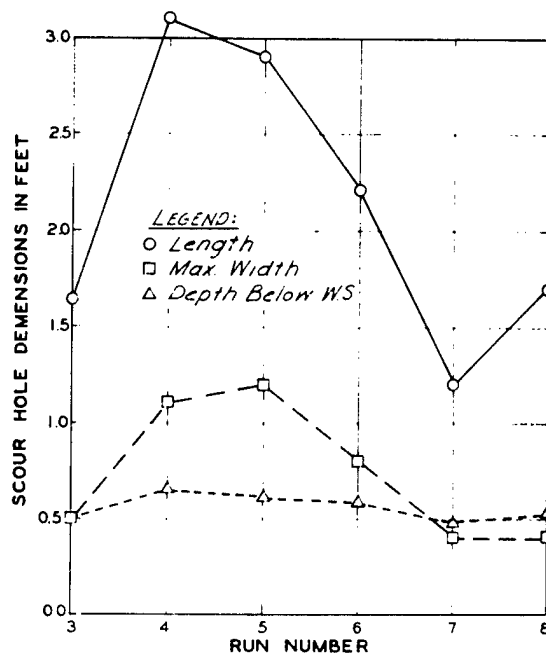
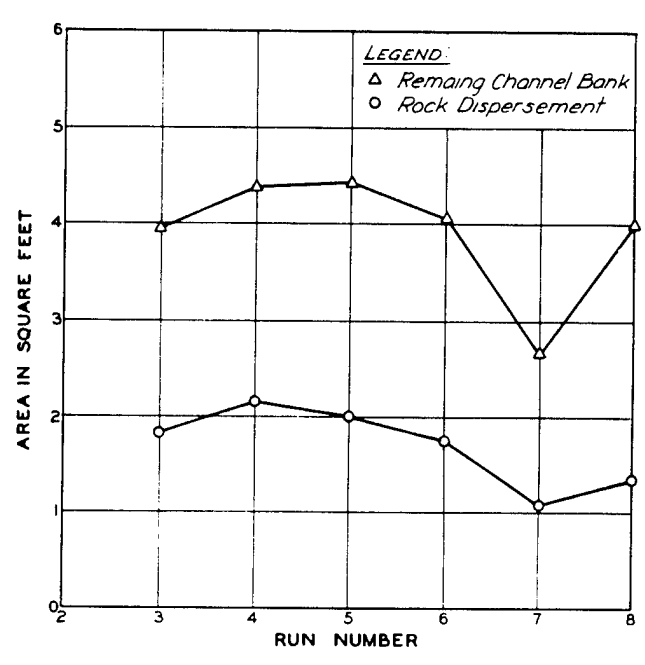
SCOUR HOLE DIMENSIONS IN FEET

SECTION 32 DESIGN STUDY
 EROSION CONTROL USING HARD POINTS
 STRUCTURE EFFECTS ON LOCAL EROSION
 U.S. ARMY ENGINEER DISTRICT, OMAHA
 CORPS OF ENGINEERS OMAHA, NEBRASKA
 OCT. 1978

The channel maps are contour charts of the channel bed. Reproductions of the channel maps are not shown in this report. These contour charts showed the general channel characteristics of size and shape of bed scour and the structure effects on local erosion. The scour hole contour maps were extracted from the channel maps to show local effects of the hard point structures. See plate 2. The data which were extracted from the scour hole contour maps were plotted on graphs so as to detect changes and evaluate trends associated with the different structure variations. See plate 3.
